CONNECTICUT COASTAL BASIN  
NEWTOWN, CONNECTICUT

CURTIS POND DAM  
CT 00312

PHASE I INSPECTION REPORT  
NATIONAL DAM INSPECTION PROGRAM

MARCH 1981

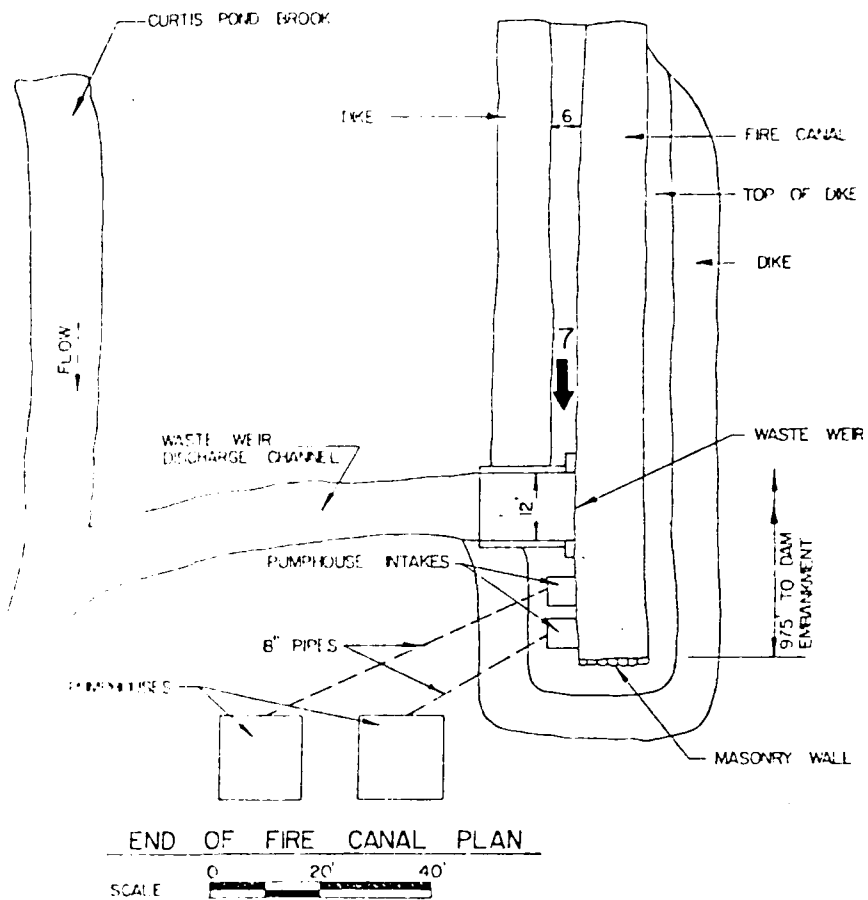
PHOTO LOCATION PLAN  
CURTIS POND DAM

The downstream slope was also overgrown with brush and heavily wooded (Photo 2). Seepage was noted emanating from the right embankment approximately 25 feet from the spillway training wall at a rate of about 1 gallon per minute (gpm). As a result, an area adjacent to the toe of the dam about 45 feet long and 15 feet wide has become marshy. The area at the toe of the left embankment, from the spillway training wall to the canal dike and extending about 100 feet along the toe of the dike, was also marshy; however, there was no visible flow above the ground. The marshy areas at the toe of the embankments and the erosion on the upstream slope have been outlined on the Photo Location Plan (Appendix C).

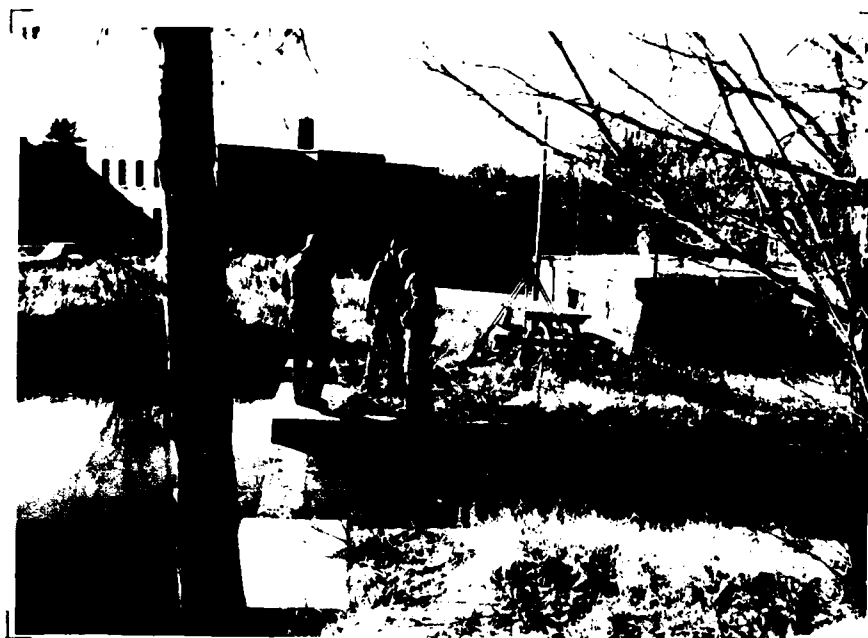
The concrete waste weir was generally sound, but some minor spalling was noted along the crest (Photo 7). The fire protection equipment, intakes, and trashracks appeared to be in relatively good condition.

Photo 7 End of canal, waste weir, pumphouse intakes, pumphouses (right), and S. Curtis and Sons, Inc. factory in background.
